StEER: Structural Extreme Event Reconnaissance Network

HURRICANE MICHAEL: FIELD ASSESSMENT TEAM 1 (FAT-1) EARLY ACCESS RECONNAISSANCE REPORT (EARR)

Released: October 25, 2018
NHERI DesignSafe Project ID: PRJ-2111

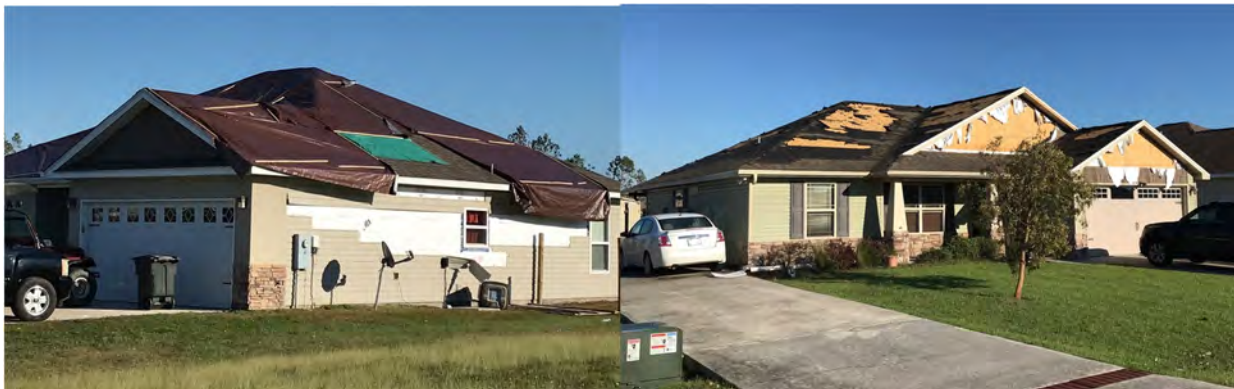
Figure 10: Damage to roof cover and building wall envelope observed in Southport

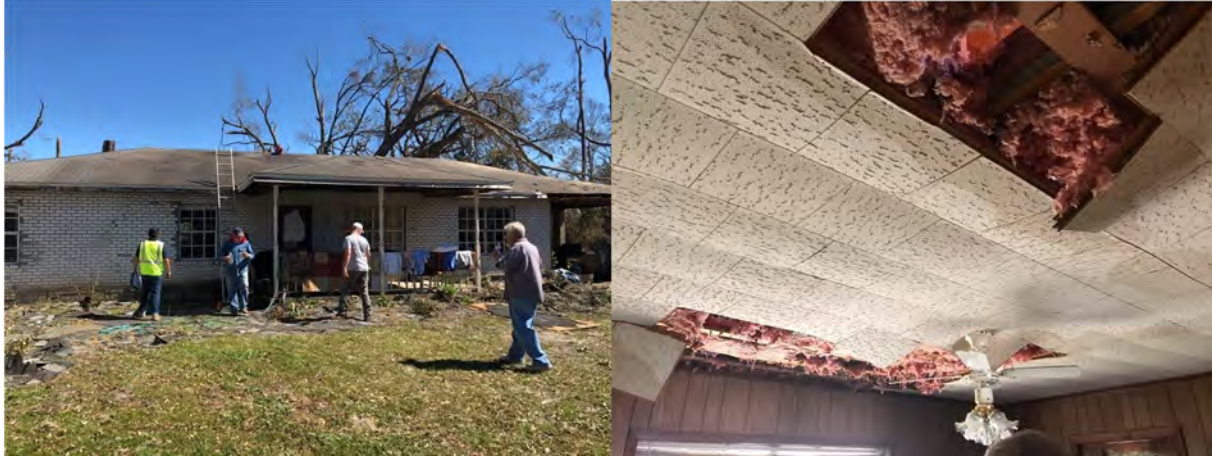
Figure 11: Example of tree damage observed in Southport

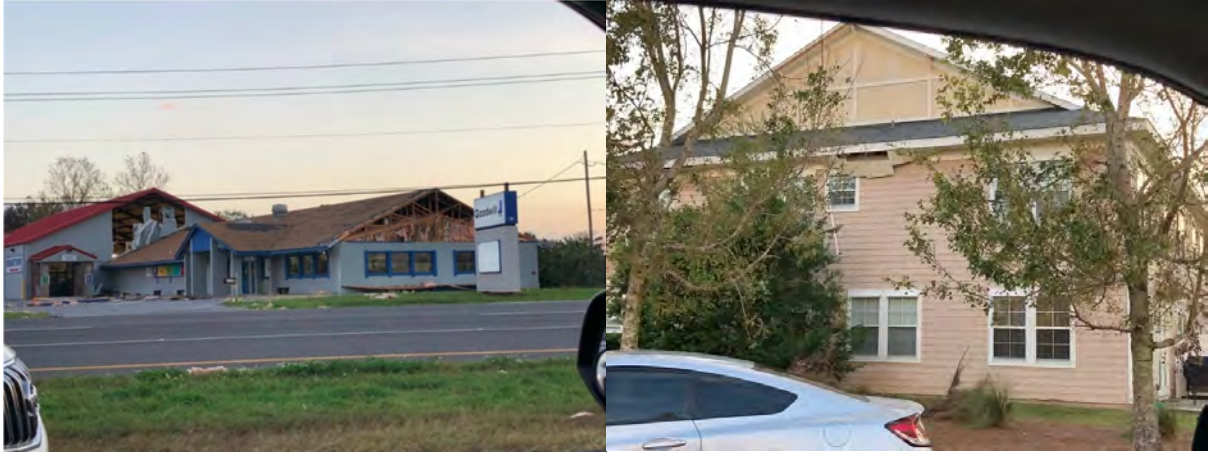
D2D assessments were conducted in Panama City Beach, Laguna, and Rosemary Beach by FAT-1 on October 14, 15, and 17 near US Highway 30 and US Highway 98. Assessments were mostly conducted between Front Beach Rd. and US Highway 98. The assessed sites are concentrated from E. Lakeshore Dr. in Laguna Beach to St. Thomas Dr. in Panama City Beach. Three commercial buildings, 2 hotels, 2 residential buildings, and 3 buildings specified as 'other' were surveyed in the D2D assessment; those sustaining damage had preliminary overall wind damage ratings of minor (N=5), moderate (N=4), and severe (N=2). Preliminary analysis of D2D data indicates damage predominantly driven by wind, which include moderate to substantial roof and wall damage. These can be described by loss of sheathing, soffit damage, gutter damage, and shingle/tile loss (Fig. 12). Damage was also observed to wood-framed buildings that were under construction at the time of the storm (Fig. 13).

Figure 12: (left) Commercial building in Panama City Beach sustaining severe wind damage. (Right) Multifamily building under construction sustaining minor wind damage in Panama City Beach.

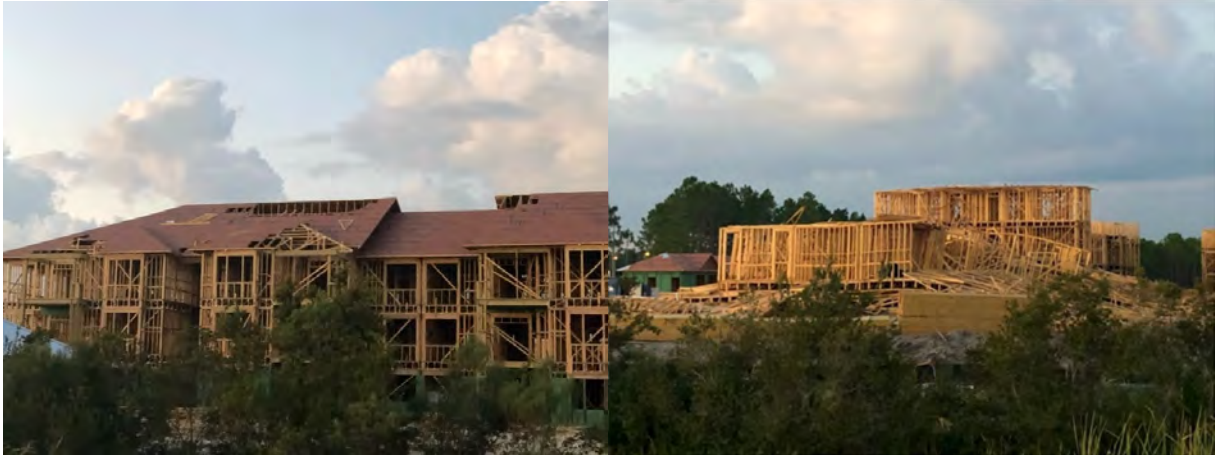
Figure 13: Construction sites in Panama City Beach sustaining moderate wind damage.

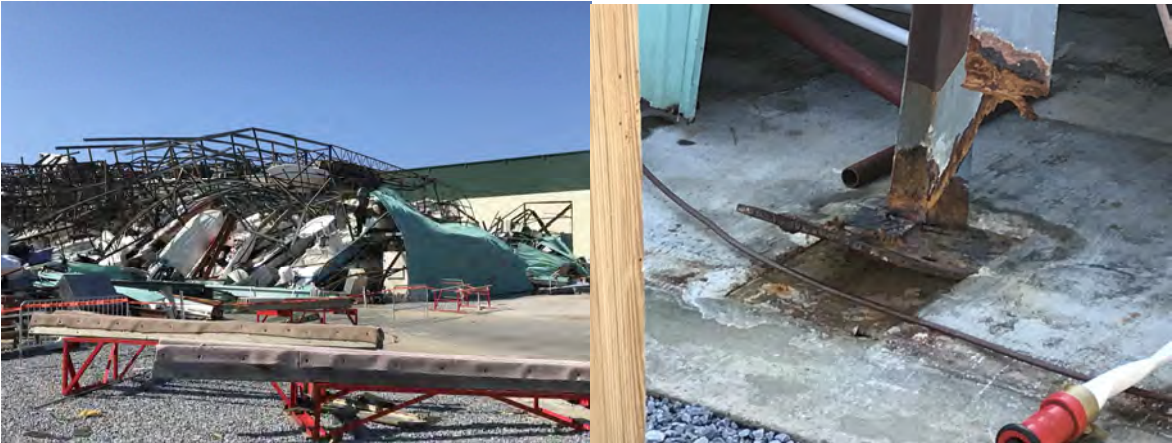
Collapse of three metal buildings associated with marinas were assessed in Panama City Beach (Figs. 14-15). While there is no doubt of the intensity of the wind speeds in Panama City Beach, forensic investigation revealed many connections of steel framing to their footings that were corroded to be point of significant loss of section and strength. In particular these conditions are likely to occur where the structures are located along the water and exposed to the environmental conditions salt air in marine locations.

Figure 14: Collapse of a storage building (left) with corrosion and material loss in columns and baseplates (right).

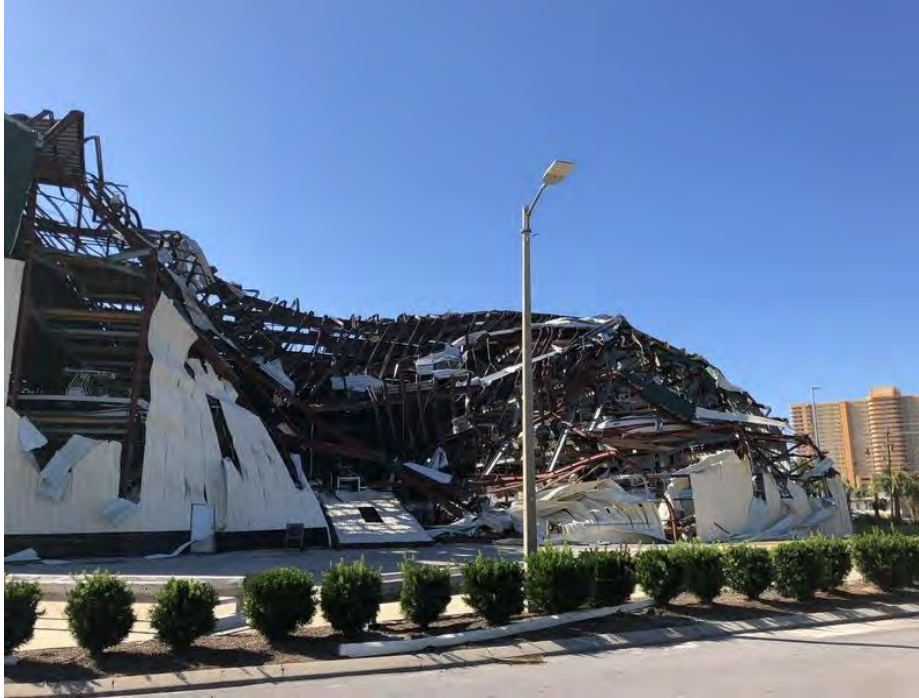
Figure 15: Partial collapse of a metal building marina in Panama City Beach.

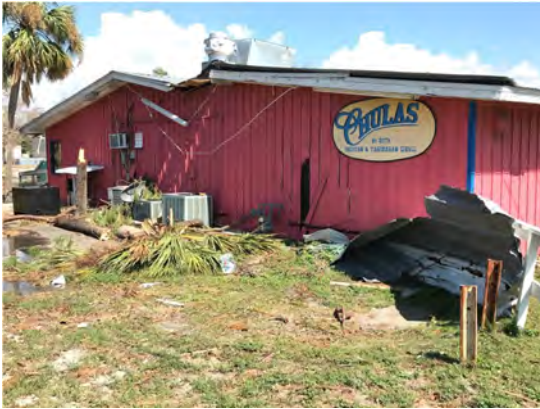
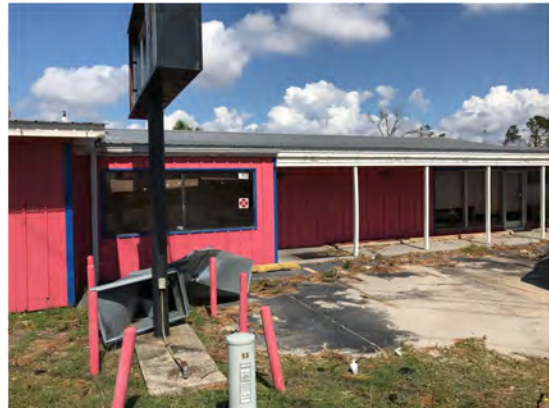
Figure 16: Commercial structure in Interior Panama City Sustaining minor wind damage.

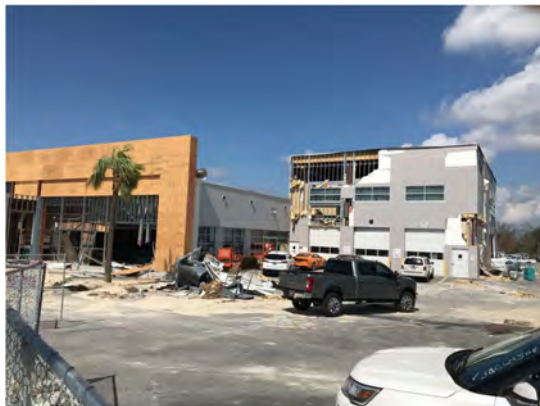
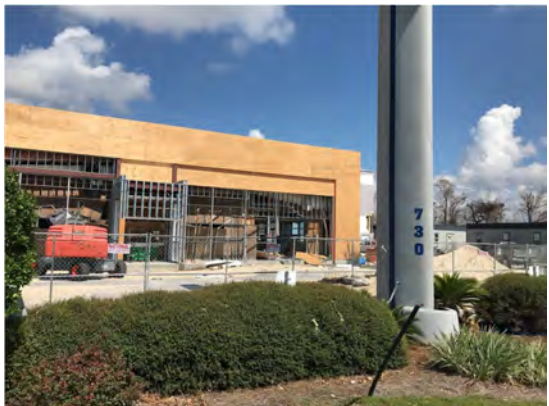
Figure 17: Commercial structure in Interior Panama City Sustaining moderate wind damage.

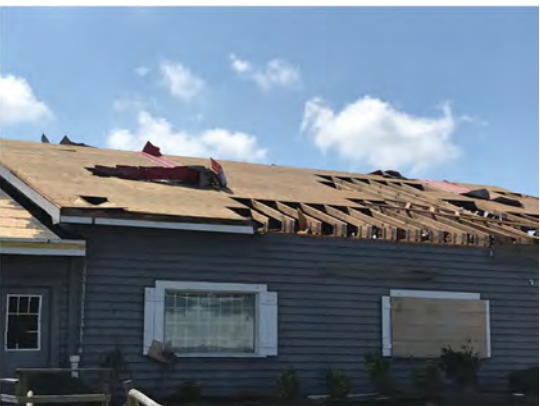
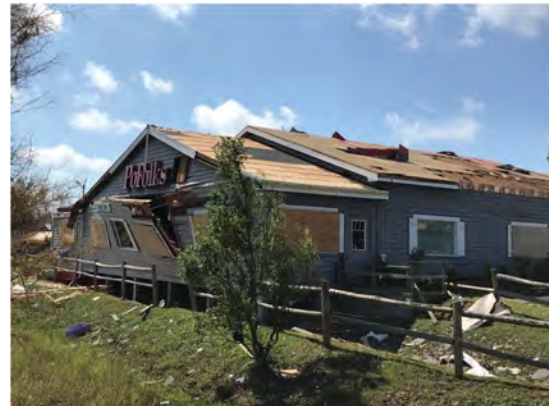
Figure 18: Commercial structure in Interior Panama City Sustaining severe wind damage.

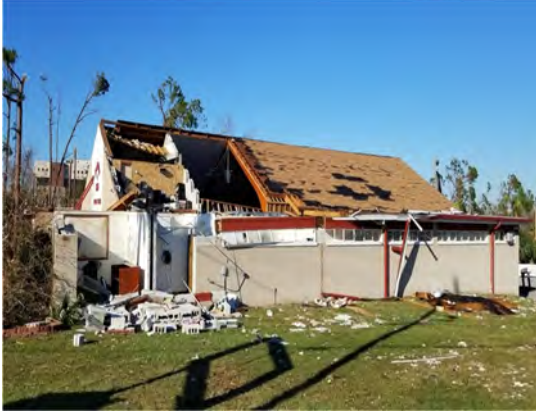
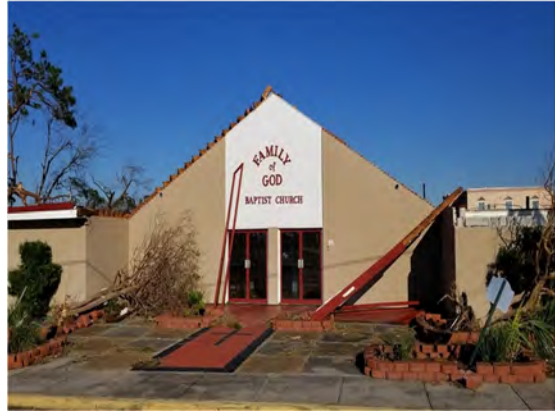
Figure 19: Severely damaged roof at Family of God Baptist Church at 901 US-98 BUS, Panama City (Captured by: Tim Johnson)

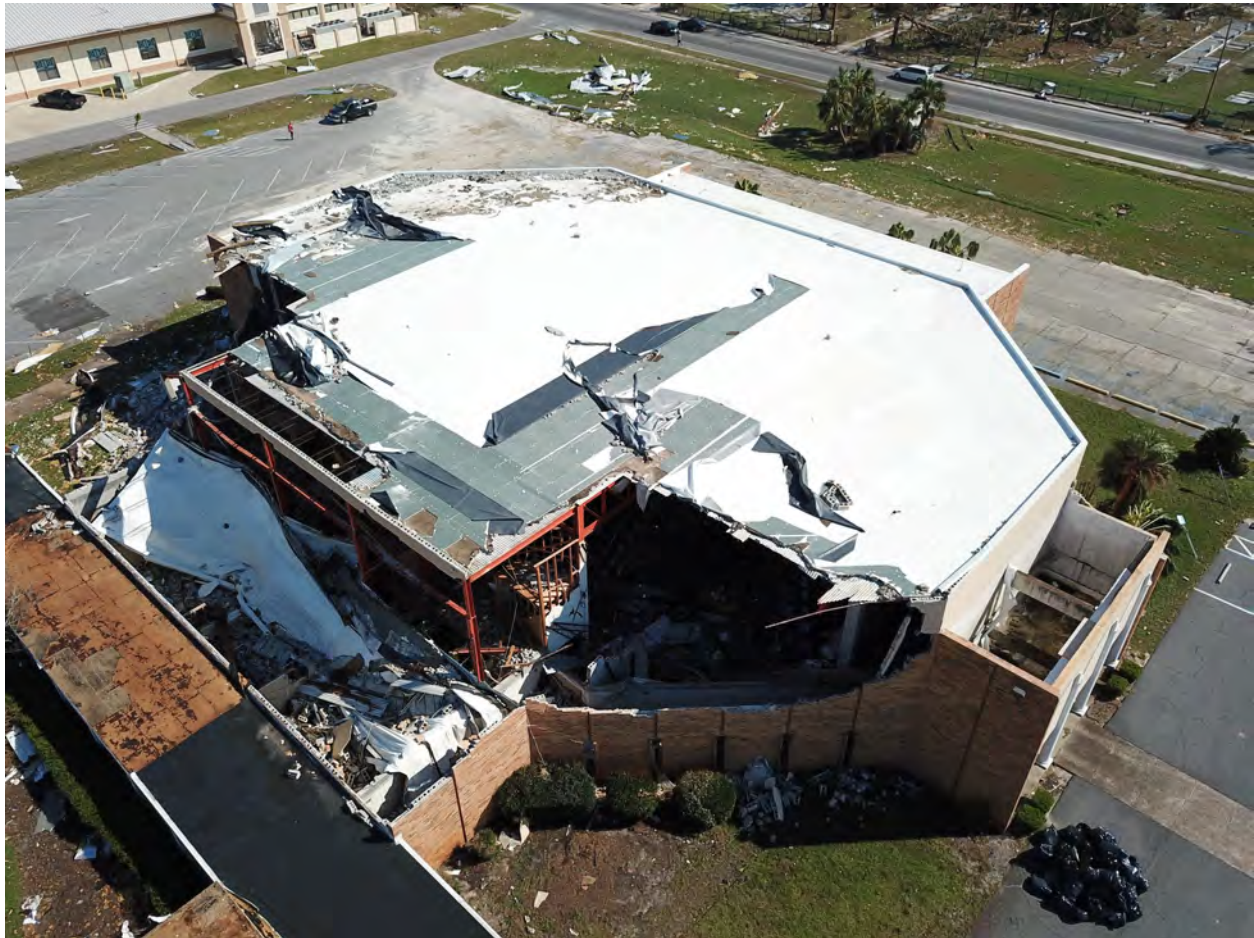
Figure 20: Failure of roof cover and exterior wall of a gymnasium at the Bay County Prep Academy (Lat: 30.16902, Long: -85.67445).

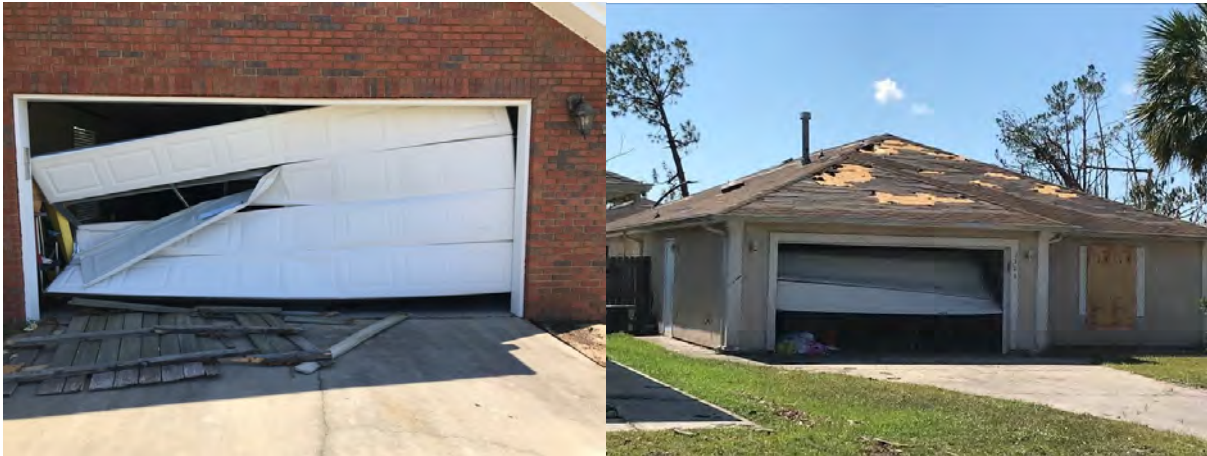
Figure 21: Garage door failures in residential homes in Cedar's Crossing.

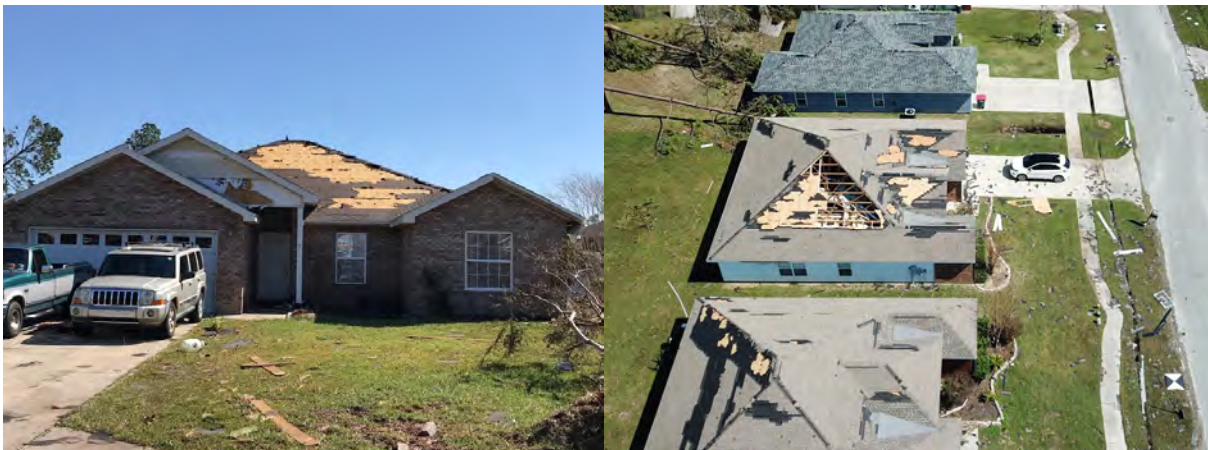
Figure 22: Damage to roof cover and roof sheathing in residential homes in Cedar's Crossing.

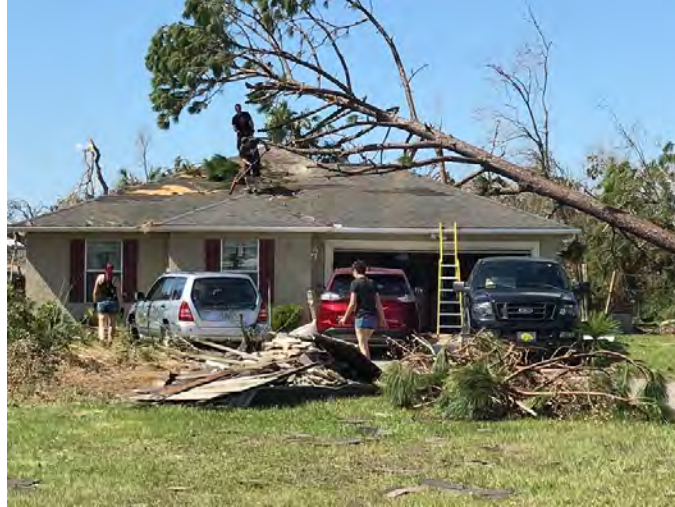
Figure 23: Example of tree damage in Cedar's Crossing.

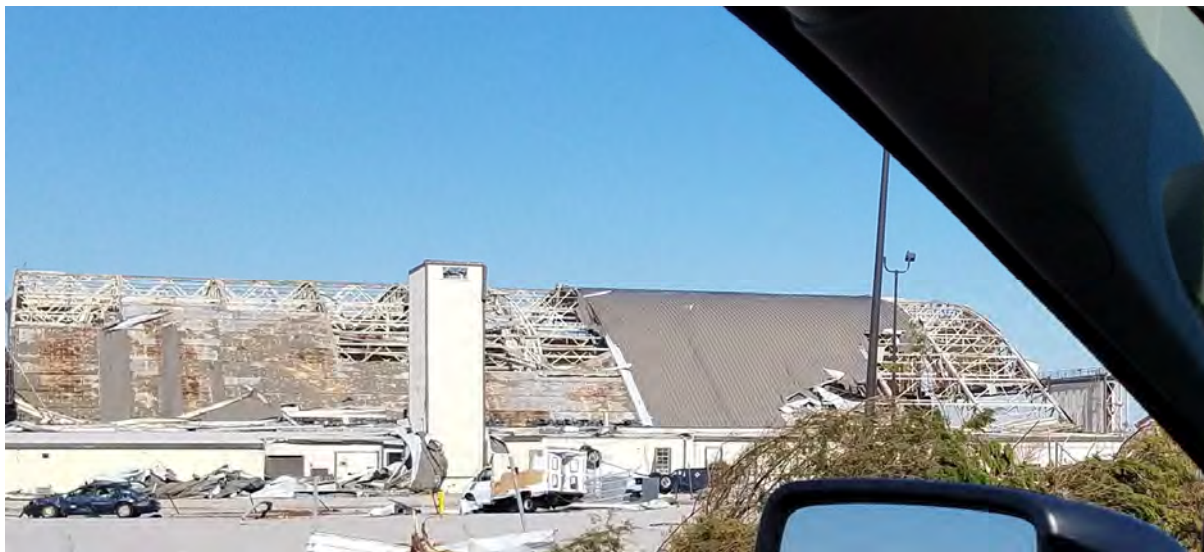
StEER did not attempt to access Tyndall Air Force Base, but significant damage to a number of buildings was observed from US-98, including several large aircraft hangars (Fig. 24), on-base housing, and experimental laboratories.

Figure 24: Severe wind damage observed to a large aircraft hangar on the Tyndall Air Force base, with almost complete failure of the corrugated metal roof cladding system.

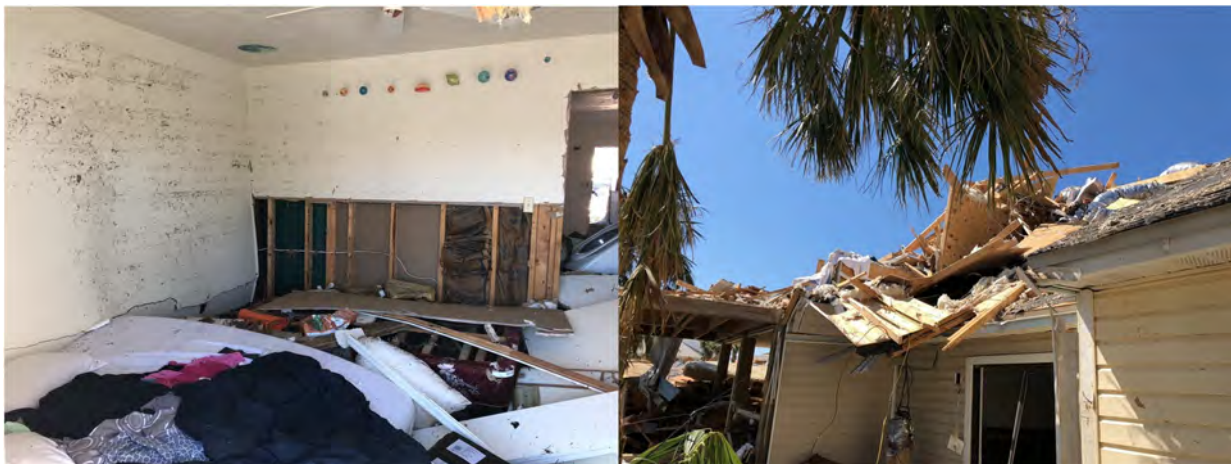
Figure 25: Example of storm surge damage in Mexico Beach. High water mark, 8" short of the 8 ft ceiling, slab is elevated 5" above ground level so surge height estimated 93" AGL.

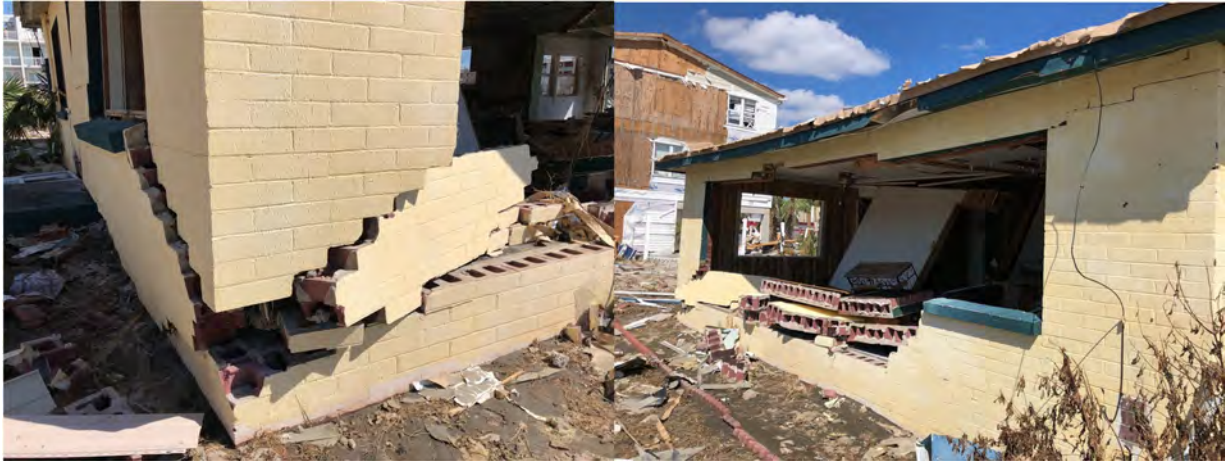
Figure 26: Severe damage to a masonry building observed in Mexico Beach (likely due to storm surge).

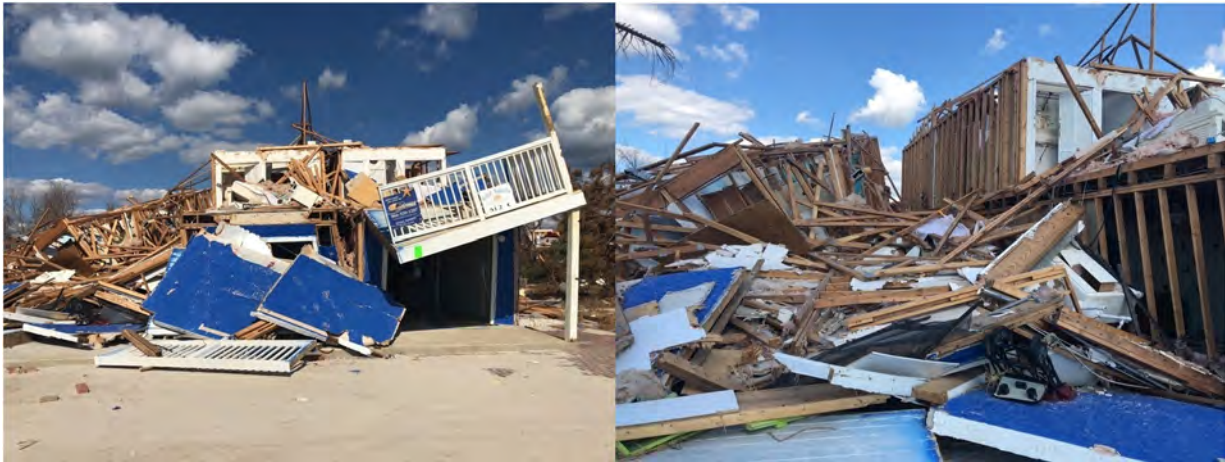
Figure 27: Example of total destruction of residential construction in Mexico Beach.

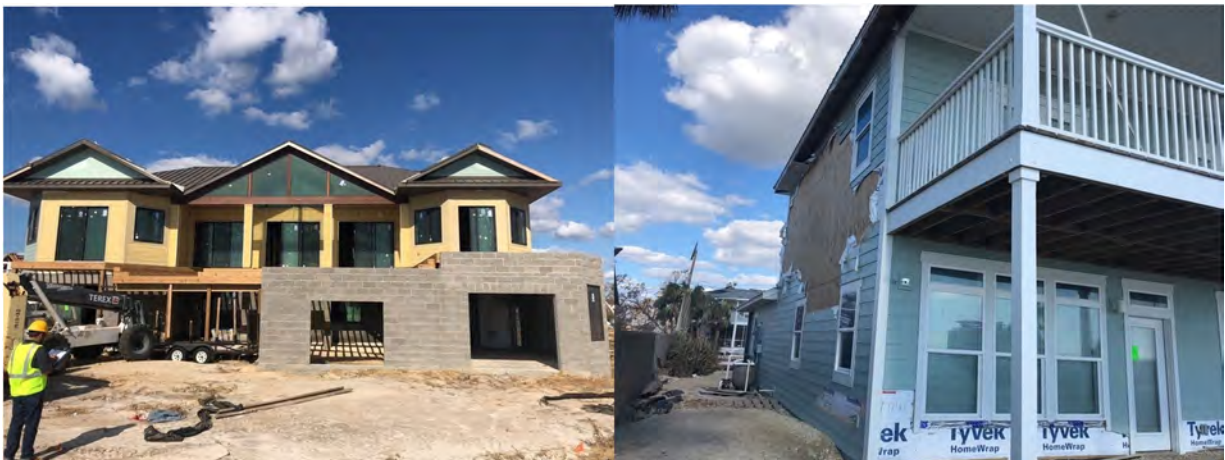
Figure 28: Newer buildings with minor damage in Mexico Beach.

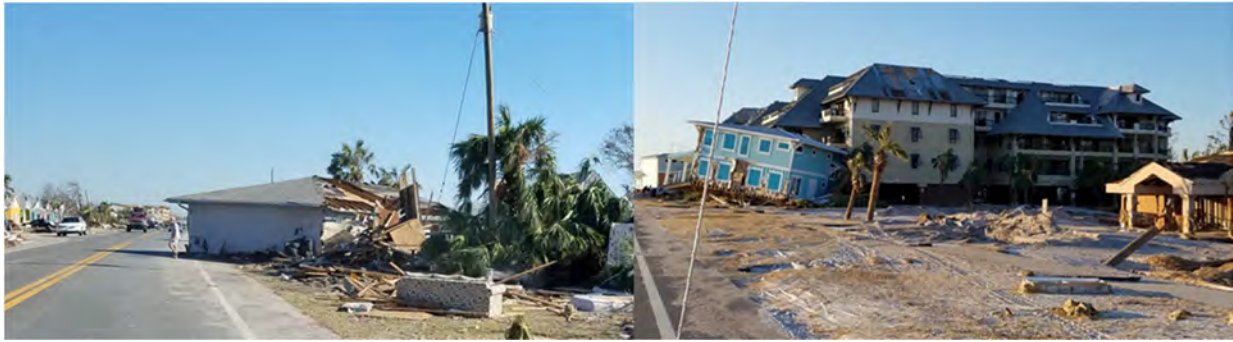
Figure 29: (left) Home pushed on to US-98 by storm surge; (right) Home pushed into multi-family residential complex by storm surge in Mexico Beach.

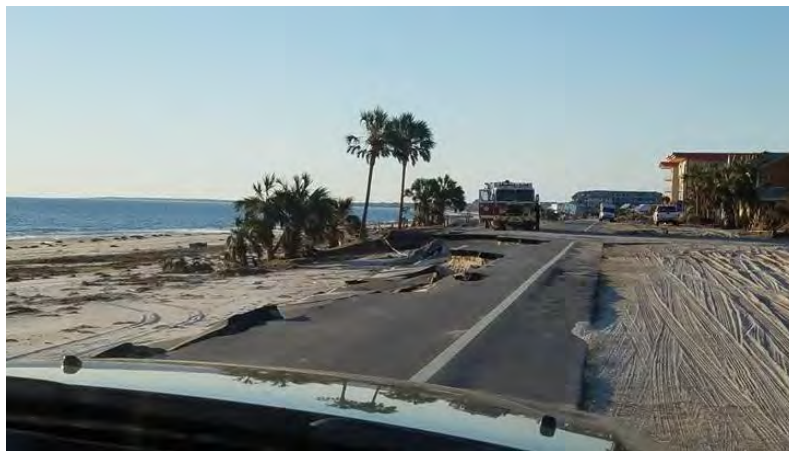
Site Conditions: Portions of US-98 are washed out (Fig. 30), limiting travel. Debris cleanup is still ongoing. Duke Energy supplies power to Mexico Beach and began restoration on October 22, but no timeline for power restoration has been made available yet.

Figure 30: Road washout near US Hwy 98 in Mexico Beach (Latitude: 29.935440, Longitude: -85.400476).

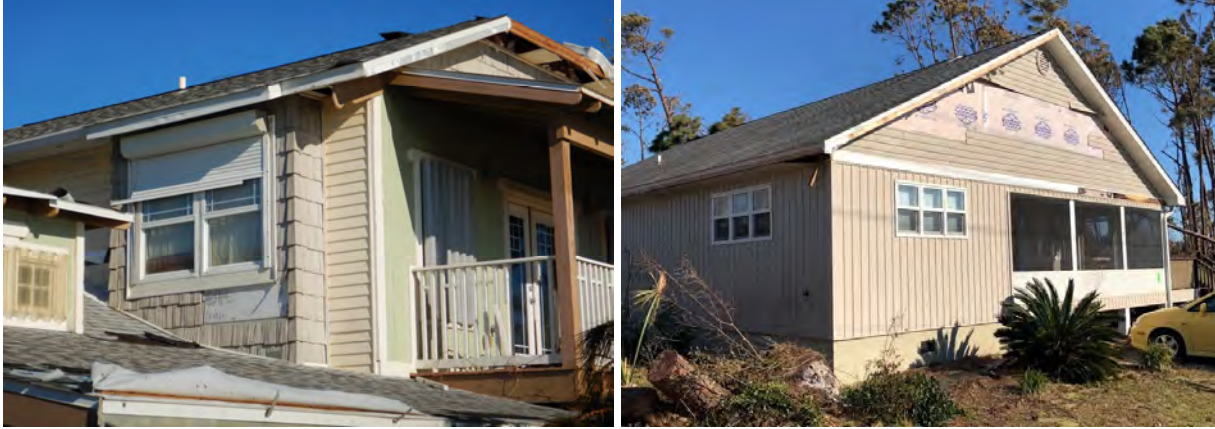
Figure 31: Examples of minor damage to homes assessed near the intersection of Highways 98 and 386 in Mexico Beach.

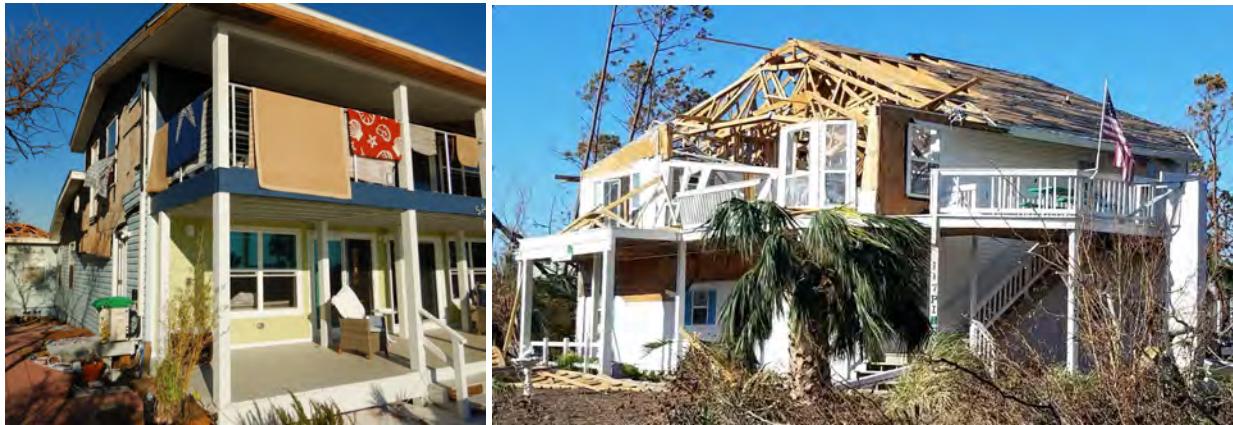
Figure 32: Examples of moderate (left) and severe (right) damage to homes assessed near the intersection of Highways 98 and 386 in Mexico Beach.

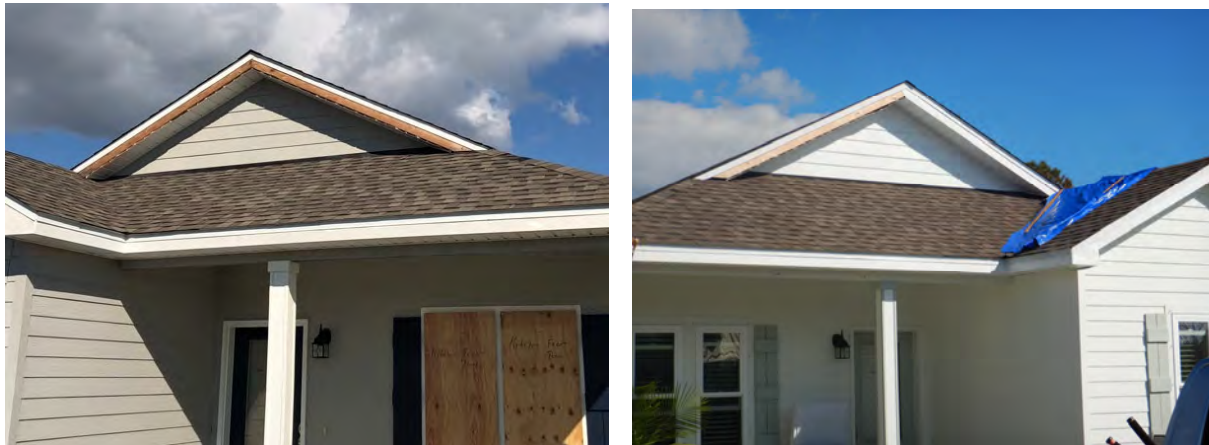
Based on discussions with the residents who were available, the homes have been built within the last five years, with some of the houses less than two years old. The primary forms of damage to these houses were loss of fascia boards and soffit damage, both under the eaves and under the entryways. There were also cases of minor shingle loss. Figure 33 shows examples of the

Figure 33: Typical fascia damage of homes in the Beacon by the Sea Community.

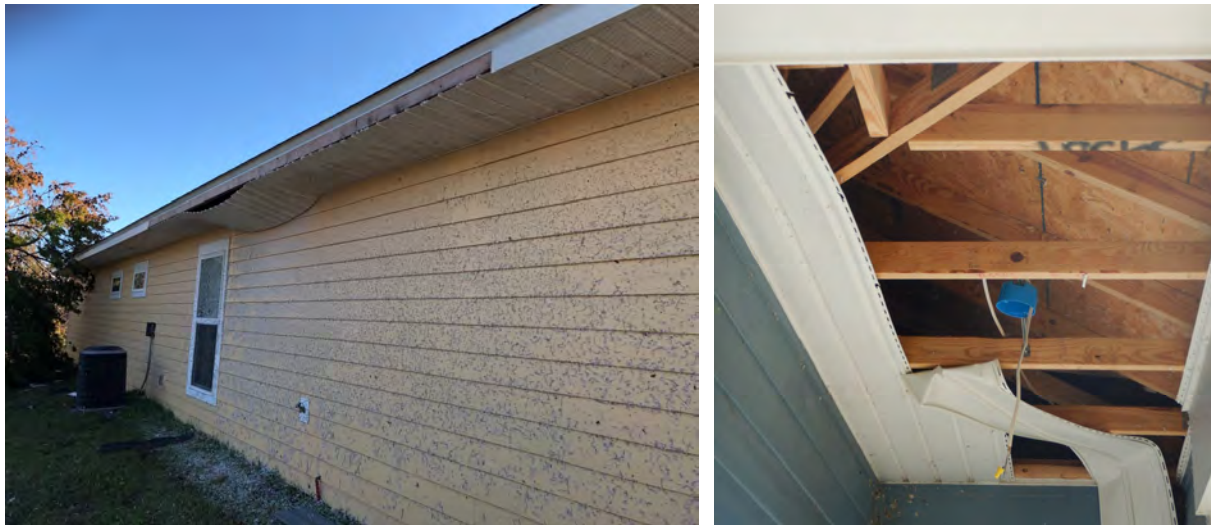
fascia loss and shingle loss. Figure 34 shows typical examples of soffit damage observed in the neighborhood. In discussions with several of the homeowners present, even when significant soffit damage and complete loss of attic insulation were documented (Fig. 34), significant water intrusion did not occur. While it was less common, there was siding damage to a few of the homes in the community, including vinyl, cement fiber and wood shake cladding systems. By far the most significant siding damage was seen in the assisted living facility adjacent to the community. Examples of siding loss are shown in Figure 35.

Figure 34: Typical soffit damage to homes in the Beacon by the Sea community.

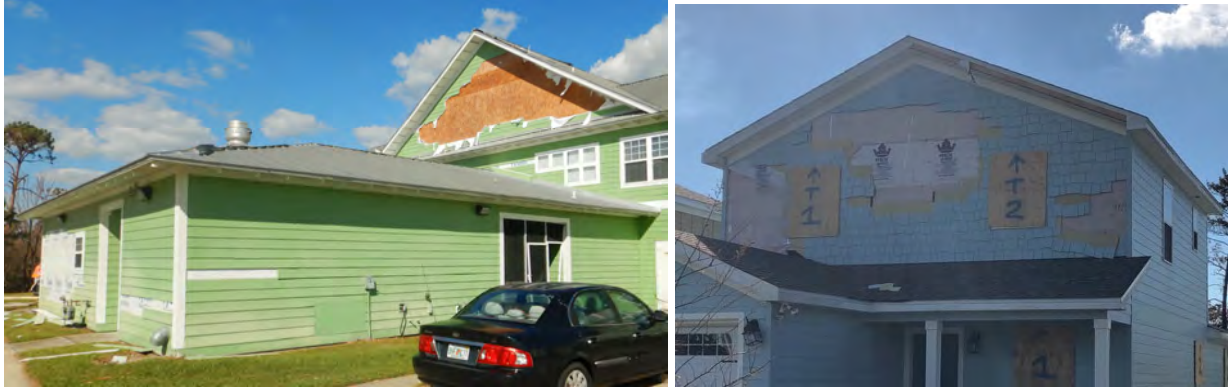
Figure 35: Examples of siding loss in an assisted living facility (left) and single family residence (right) in the Beacon by the Sea community.

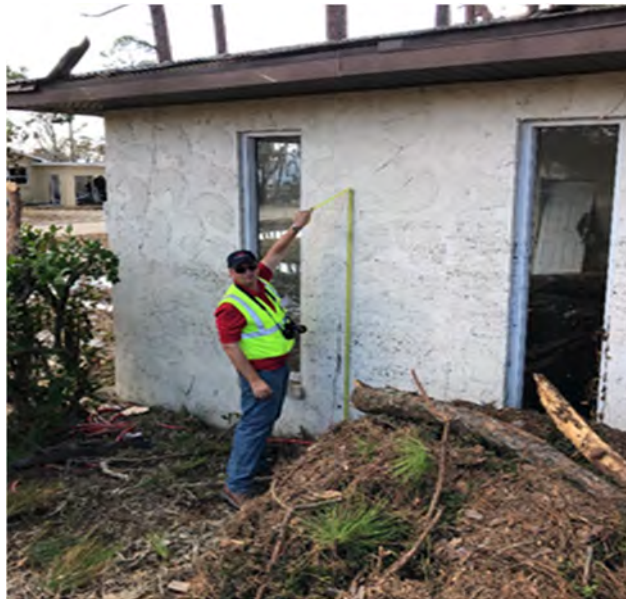
Surge high water mark of 72" was measured at Port St. Joe as shown in Figure 36. Wind damage was also severe in Port St. Joe, generally trending toward moderate and minor moving farther South. In general, it was seen that the surge footprint extended much farther south than the high-wind footprint. A surge-induced bridge failure (Fig. 37) was observed on 30A just South of Country Club road. New homes (less than 5 years old) along Four J's Rd. and Kaelyn Ln., less than a mile northeast of FCMP T2, performed very well. All were single-story, most with gable roofs, and with a mix of wall cladding and roof cover materials. Most had engineered wood panels installed to protect glazed openings. Isolated roof cover and wall cladding damage was observed. Vinyl siding failed more frequently, typically in small lengths. Fascia damage was common. Conversations with multiple homeowners revealed no significant water ingress through the building envelope, even to homes with soffit damage (Fig. 38).

Figure 36: Surge high water mark (72") in Port St. Joe.

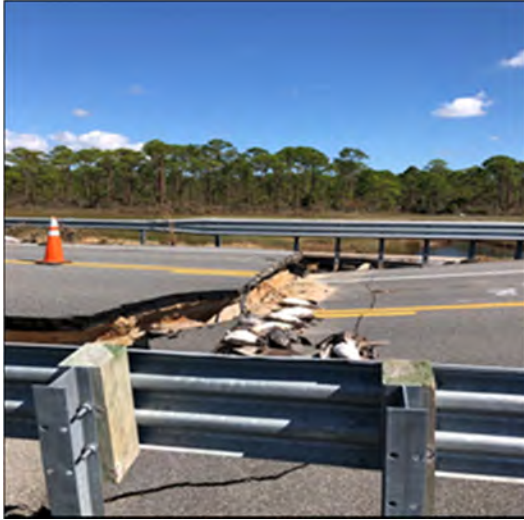
Figure 37: Surge-induced bridge failure on 30A South of Port St. Joe: (a) buckled road surface; (b) scour at abutment support.

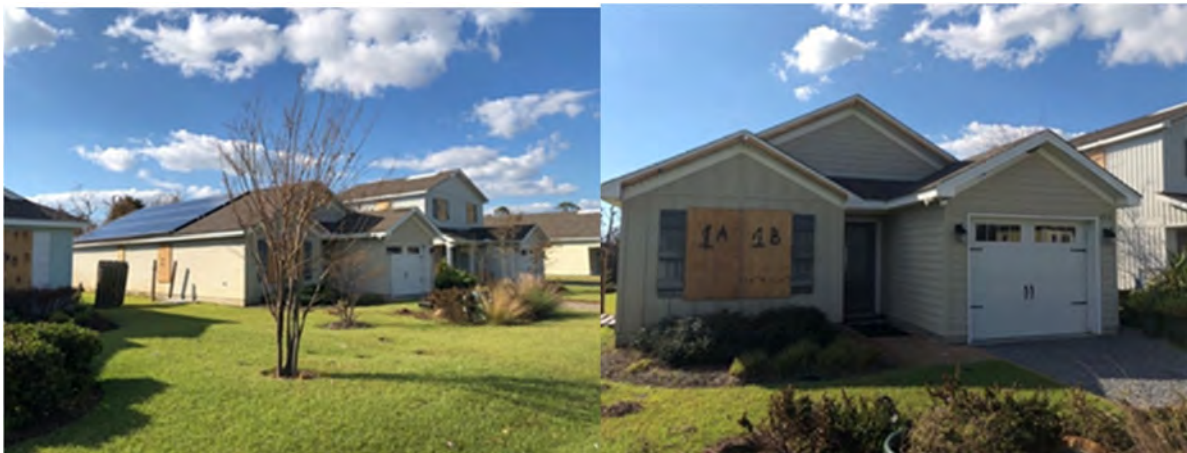
Figure 38: Residential structure in Port. St. Joe with solar panels intact (left) and minor vinyl soffit damage to front elevation (right), windows were covered with plywood.

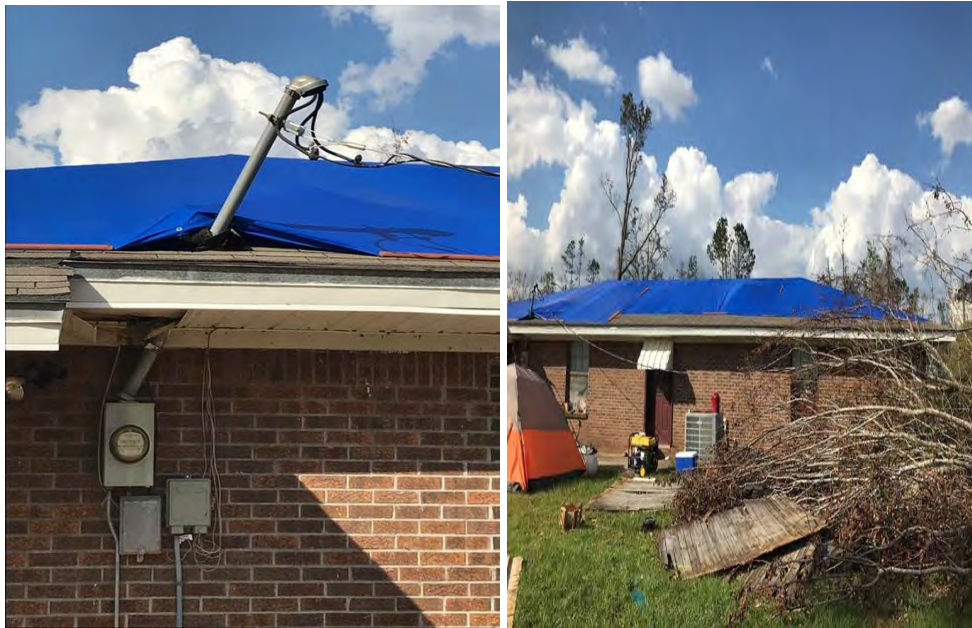
Figure 39: Damaged electricity conductor present in a building near Lambert Ave. in Blountstown.

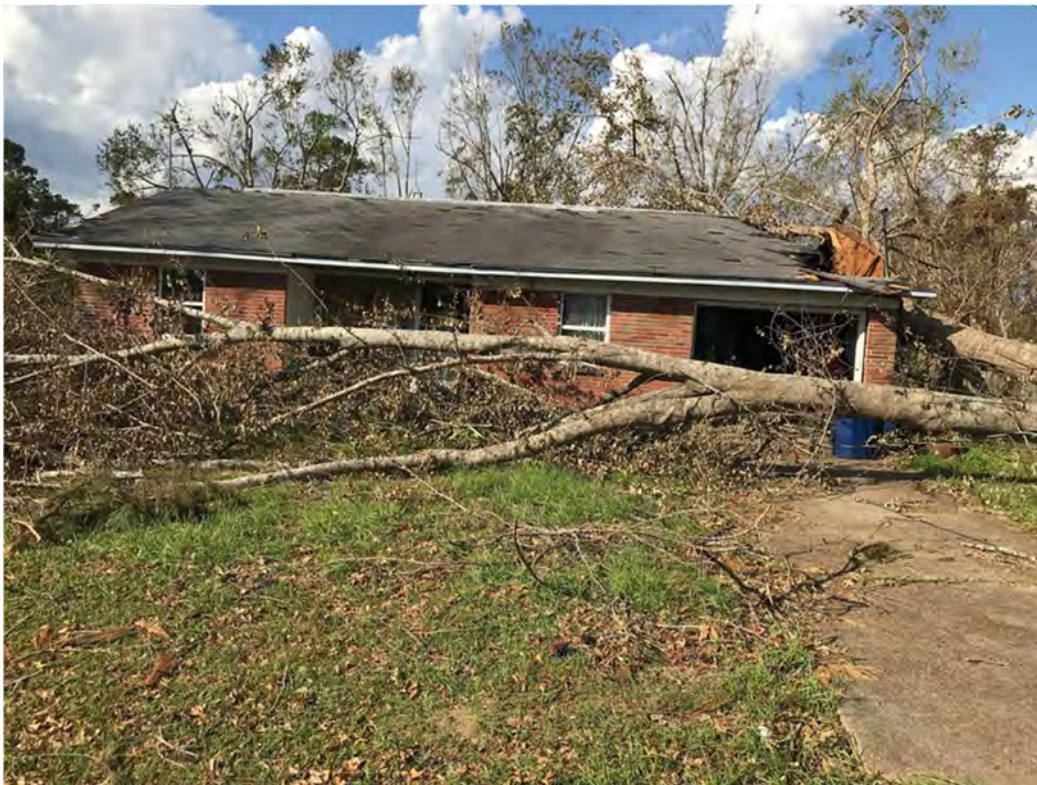
Figure 40: Residential building sustaining severe damage due to tree fall at NE Lambert St. in Blountstown.

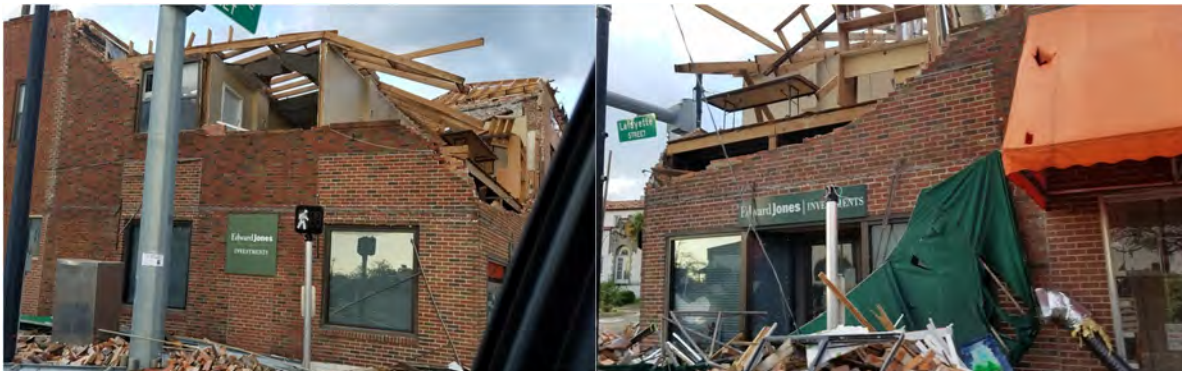
Figure 41: Commercial building (Edward Jones investments) with wall collapsed and roof structure damaged on Lafayette St. in Marianna.

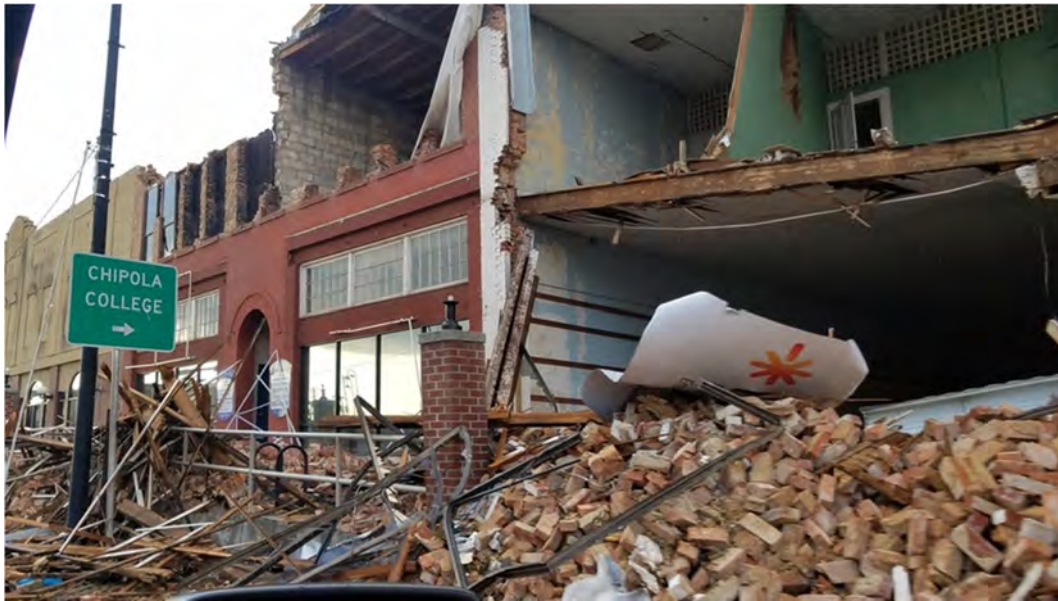
Figure 42: Commercial buildings with masonry walls collapsed and roof structure damage on Lafayette St. in Marianna.

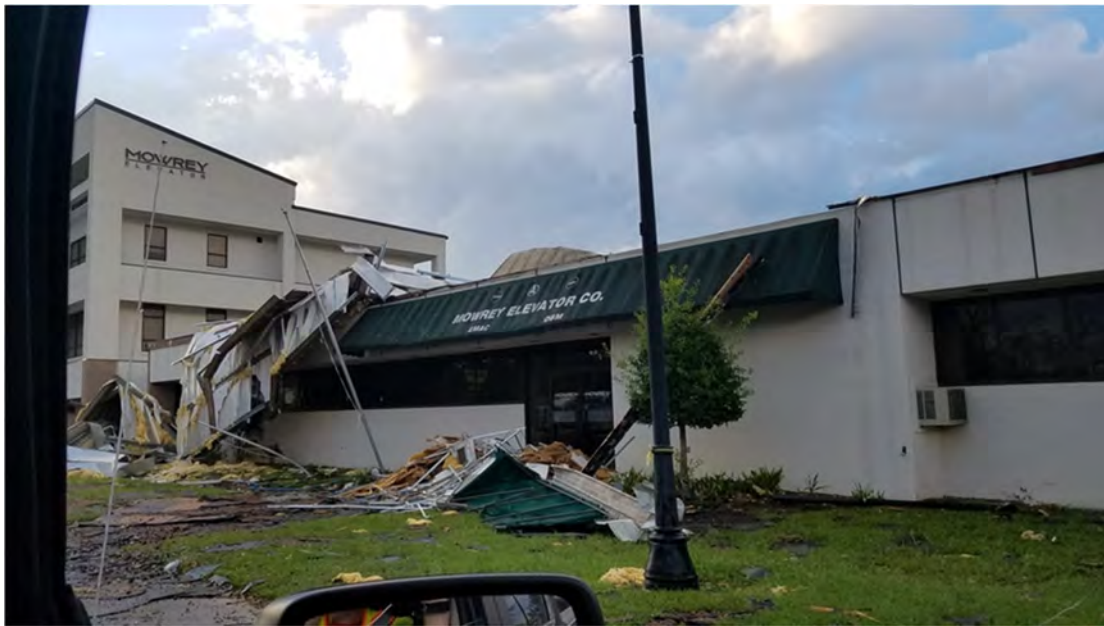
Figure 43. Commercial building (Mowrey Elevators) sustaining severe roof damage on Lafayette St. in Marianna.

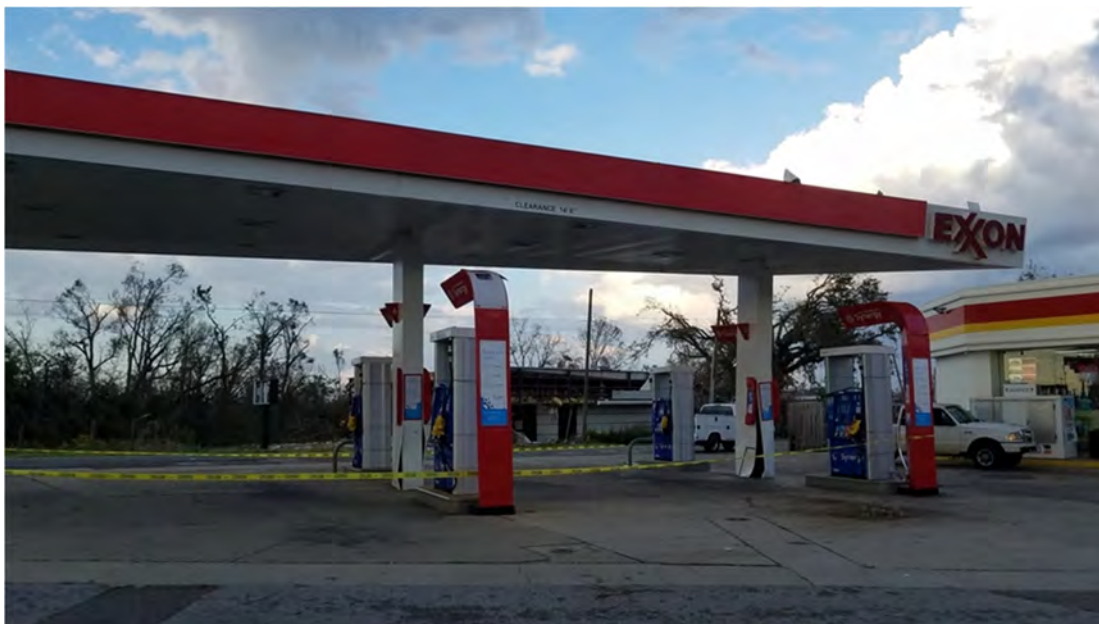
Figure 44: Exxon station sustaining column and roof damage at US 90 in Marianna.

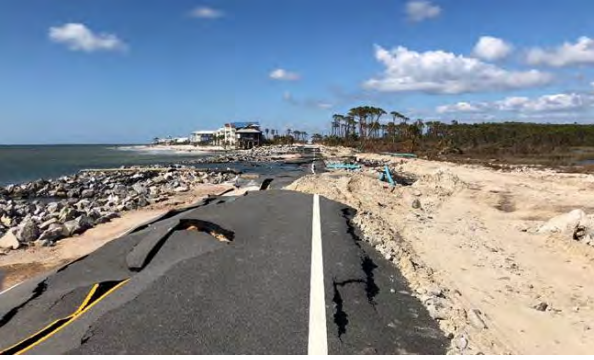
Figure 45: Road washout on Highway 30E (Cape San Blas Rd) on Saint Joseph Barrier Island (Latitude: 29.680619, Longitude: -85.366115).

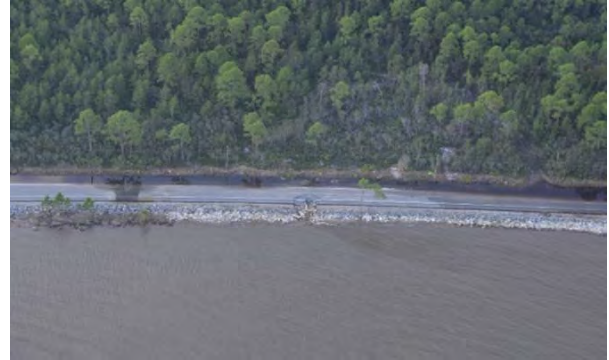
Figure 46: Road wash out US Hwy 98 (Big Bend Scenic Byway Coastal Trail) (Latitude: 29.772736, Longitude: -84.793465) (Source: [ESRI StoryMap](#)).

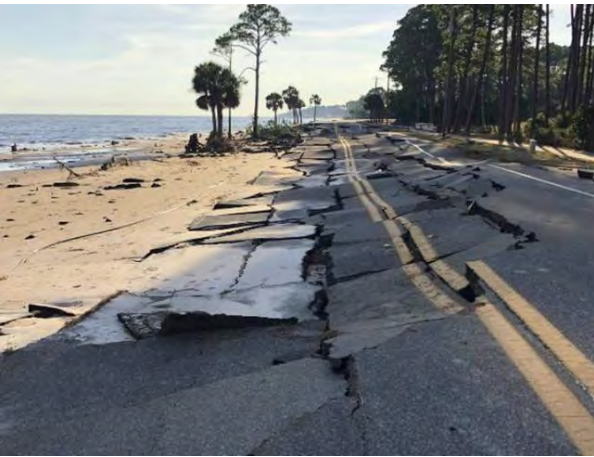
Figure 47: Road washout US Hwy 98 near Carrabelle (Latitude: 29.827057, Longitude: -84.696981) (Source: [ESRI StoryMap](#)).

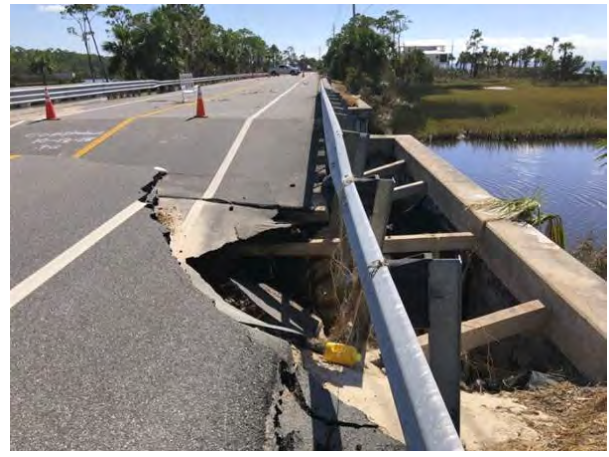
A majority of closures that were reported in the P-VAT report have been lifted as they constituted cautionary closures due to high winds or water or debris over the roadways/bridges. The remaining closures or loss of access are mostly due to sustained damage. The damage could be categorized as follows: damage to roadways due to raised water levels that resulted in washing out the subgrade (Figs. 45-47) or those due to high levels of storm surge (and potentially waves in some locations) that resulted in failure of bridges spans, approaches, and abutments (Fig. 48).

Figure 48: Bridge approach washout on Highway 30A Bridge near Saint Joseph Bay (Latitude: 29.754006, Longitude: -85.303750).
