## Hurricane Ian

Released: November 16, 2022

NHERI DesignSafe Project ID: PRJ-3709

### PRELIMINARY VIRTUAL RECONNAISSANCE REPORT (PVRR)

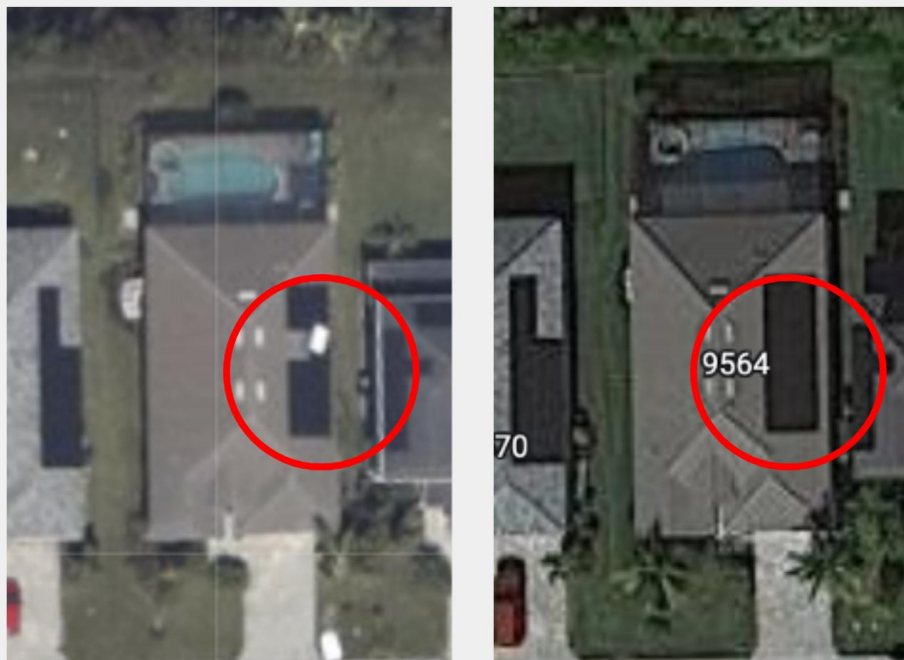
Beyond Babcock Ranch, however, aerial imagery from NOAA revealed damage to roof solar panels in areas that observed higher peak wind gusts. A preliminary assessment conducted in multiple neighborhoods in Cape Coral and Fort Myers identified 30 rooftop panel installations with severe damage (Fig. CS.5.1). An example of typical damage is shown in Fig. CS.5.2. Field inspections can reveal less visible damage to the panels ([Burgess & Goodman, 2018](#); [Ceferino et al., 2022](#)), identify specific failure mechanisms (e.g., cracks and local failures in the rack, panel connection, or roof attachment), and evaluate the impacts on continuous power access and building functionality.

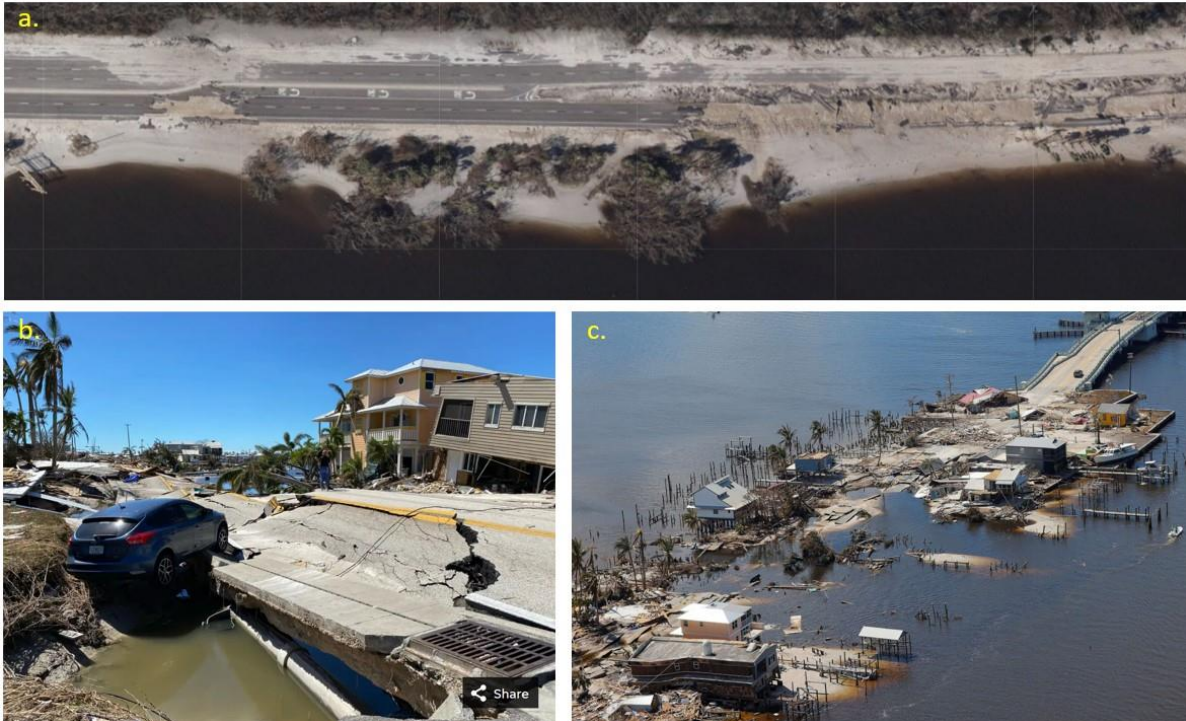
**Figure 5.3.** Observed damage coastal roadways, including (a) the McGregor Blvd in Fort Myers (source: NOAA Hurricane Ian Imagery), and (b), (c) the Pine Island Rd (Source: ABC news (2022) and Levy (2022) respectively).

Figure 5.2 summarizes the progression of road closures during the landfall of Hurricane Ian, initiating with coastal roadways and causeways in Lee County inundated by storm surge, which in several cases caused structural damage. This includes all the bridges to Pine Island (Gallman, 2022), the roadway connecting Captiva and Sanibel Islands, the Sanibel Causeway connecting Sanibel Island to Fort Myers (Levy, 2022), the Big Hickory Bridge, and Little Hickory Bridge (fl511.com). Damage was also observed to coastal highways in Fort Myers, with the most characteristic case being McGregor Blvd. The most common pattern of failure was the severe coastal erosion near the causeways and roads that led to scour and partial damage (e.g., differential settlements) or washout of pavements and causeways, and the damage to approach slabs, as shown in Figure 5.3.

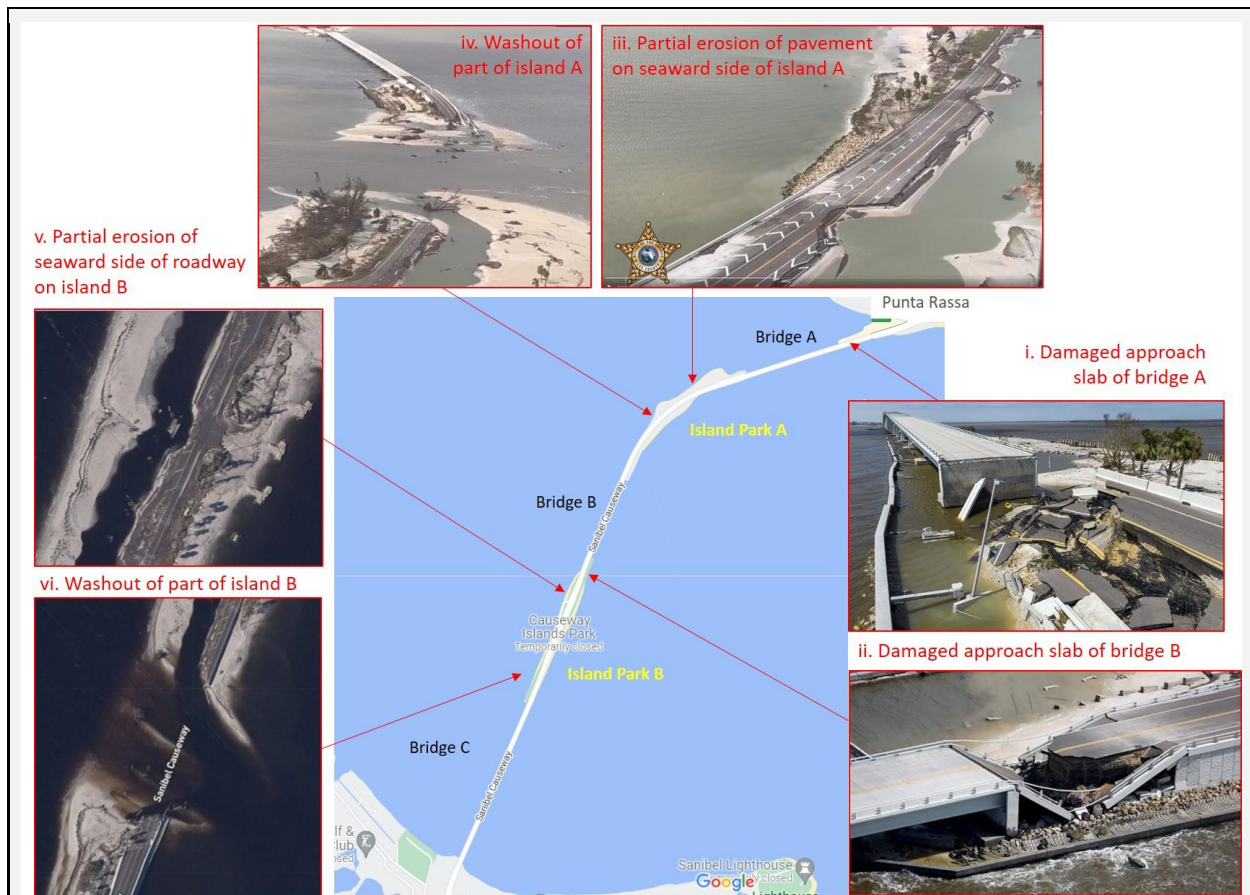
A notable case is the failure of the Sanibel Causeway, experiencing three different types of damage at different locations (see Fig. CS.5.3). The Sanibel Causeway consists of three bridges (A, B, C) and two islands (Causeway Island Park A, B) as shown in Fig. CS.5.3. Interestingly, in contrast to past hurricanes (e.g. Hurricane Katrina) that had uplifted bridge superstructures in multiple locations of the Gulf Coast Region, in this case the superstructures and their connections to the substructure (piers) were intact and the damage occurred at the approach slab of both Bridge A (on the mainland side) and Bridge B (on the south side). In both cases the approach slab was elevated (same elevation with the bridge span) and was supported on backfill material that was protected by wing-walls consisting of modular panels restrained by soil anchors embedded in the compacted fill. These panels were exposed to lateral loads from the surge and the waves. Since there is no observed erosion of the area in the vicinity of the wing-walls, it could be hypothesized that the lateral hydrodynamic loads made some of the panels unstable, which exposed the backfill material to hydrodynamic actions and scour. Once the backfill material started undergoing scour, the vertical pressures that were applied by the backfill on the slab and helped keep the slab in place were reduced, essentially leading to a simply supported slab.

**Figure CS.5.3.** Observed damage to Sanibel Causeway, including damage to approach slabs of bridge A (Source: Lasey (2022) and B (Source: Brackett and Wesner Childs, 2022), erosion and washout of island A (Source: Lee County Sheriff's Office) and erosion of island B (Source: NOAA Hurricane Ian Imagery).

Two other types of damage were also observed in the Sanibel Causeway, particularly 'at the two islands. The first type was the partial damage of the pavements on the seaward side, which was caused by the erosion of the soil below the roads, and the second type was the total washout of the road with the island below it (see Fig. CS.5.3). Interestingly, for both island A and B, the first type of damage occurred towards the north side of the island and the second type (total washout) occurred towards the south end. As shown in Figure CS.5.4, for island A at the location where a total washout was observed, the road was very close to the shore, which means that it could be exposed to surge and direct impact from the waves. On the other hand, at the location with partial damage and scour of the pavement, the road was located further from the shore. This would consequently imply that while in the former case the road would be subjected to hydrodynamic effects (e.g., scour) immediately after the instant at which the surge and waves reached the elevation of the road, in the latter case the road would be subjected to the same effects only after the sandy beach (on the seaward side) would have been eroded. Apart from this hypothetical explanation, other potential reasons that could have contributed to the different levels of damage are (i) differences in road elevations, (ii) directionality effects which may be important in the case of skewed bridge superstructures subjected to extreme

waves (e.g., Istrati and Buckle, 2021), (iii) differences in bathymetry, or (iv) other reasons not evident at this point.

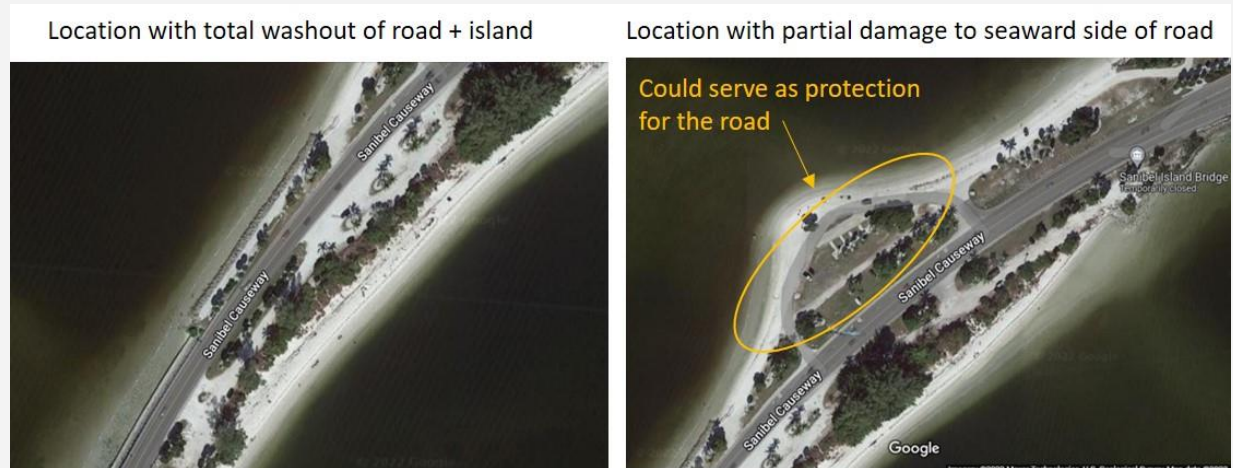
**Figure CS.5.4.** Selected locations of Causeway Island Park A before Hurricane Ian (modified from Google Maps).
